OPERATING EXPERIENCE WEEKLY SUMMARY

Office of Nuclear and Facility Safety

January 30 through February 5, 1998

Summary 98-05

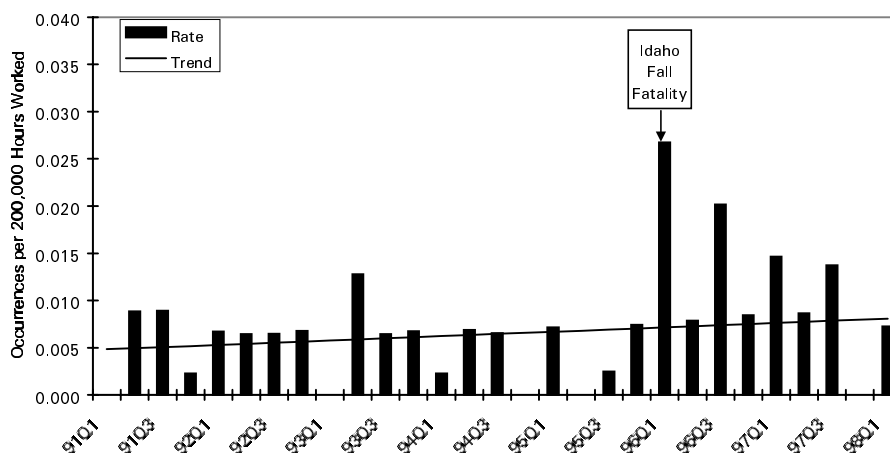
OEAF engineers searched the ORPS database for reports involving the lack of fall protection and found 86 occurrences. We established rates and the trend of occurrences by normalizing the number of occurrences to the number of hours worked. We determined that reporting of fall protection issues was relatively constant until the first quarter of 1996, when a fall fatality occurred

at Idaho National Laboratory. We believe that after the Idaho event, DOE facilities became more aware of the safety issues involved and were finding and reporting more occurrences. However, this trend has declined since 1996, and occurrences are currently being submitted at approximately the same rate as before the Idaho event. Figure 3-1 shows the distribution of occurrences by quarter versus the number of occurrences per 200,000 hours worked.

Figure 3-1. Lack of Fall Protection Events¹
